# **Property Inspection Report**

LOCATED AT: 3824 Madison Street Culver City, California 90201

INSPECTED ON: Tuesday, September 8, 2015 at 11:30 AM

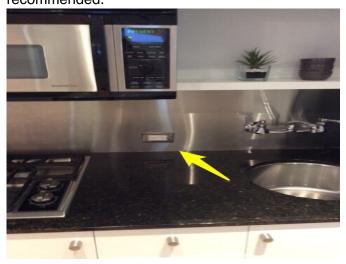
The GFCI protection for the receptacle adjacent to sink functioned correctly with the test button The GFCI receptacle at 1st floor sink area was not operational with the test button. Repair is recommended.
